# OXIDE FILM AND POROSITY DEFECTS IN MAGNESIUM ALLOY AZ91

Liang Wang<sup>1</sup>, Hongjoo Rhee<sup>1</sup>, Sergio D. Felicelli<sup>1,2</sup>, Adrian S. Sabau<sup>3</sup>, John T. Berry<sup>1,2</sup>

Keywords: Magnesium alloy, AZ91, Oxide film, Defect, Porosity

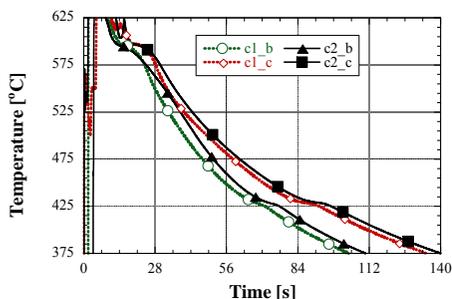
Figure 3. Cooling curves for AZ91 Mg alloy castings in mold type C.

temperature decrease during pouring (Figure 2). The mold was not preheated and was coated with boron nitride. In order to assess the reproducibility of the results, two molds were used. Temperature data was acquired with thermocouples type K at a sampling rate of approximately 60 Hz. The measured cooling curves are shown in Figure 3. The cooling curves are labeled in the following format: xn\_m, where x – is a letter, indicating the mold type, n – indicates casting number (1 or 2), and m – indicates thermocouple location (b-bottom of casting, c-center of casting). The cooling curves show an excellent reproducibility. The data measured by the thermocouple near the top of the casting was discarded because of turbulence in this region. As shown in Figure 3, the cooling rate during solidification for the AZ91 alloy castings was approximately 3.0 °C/s. In this article, results for only one mold type, denoted as type C, are reported. Analysis of castings in other graphite and ceramic molds of different dimensions will be reported elsewhere.

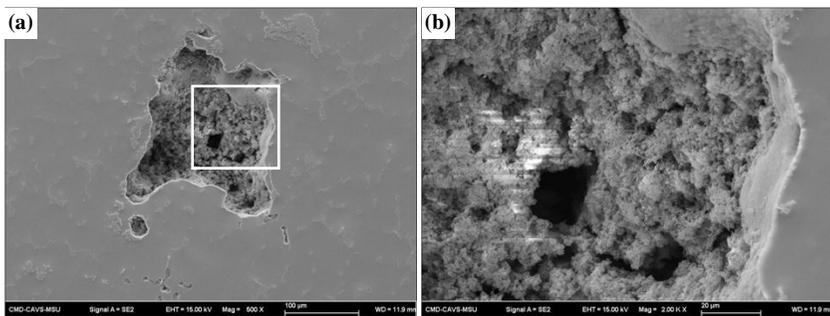
Figure 5. (a) Typical pore morphologies formed at the location close to the thermocouple in casting AZ91 C1 sample; (b) higher magnification (2000X) of image (a).

Porosity was the major defect observed in the tested specimens. Pores ranging in size from 100  $\mu\text{m}$  to 500  $\mu\text{m}$  were found in many of the polished surfaces. Figure 5 shows typical pore morphology at a location close to the thermocouple in the AZ91 C1 sample. A magnified view (Fig. 5(b)) reveals dendrites protruding into the pore as well as pieces of oxides on the surface of the pore. EDX spectroscopy shows a three-fold increase of the oxygen content inside the pore compared with the surrounding matrix. This pore was most probably caused by interdendritic shrinkage, however, the presence of oxides might suggest also a pore formed by an entrained double oxide that was torn apart by shrinkage-induced shear forces.

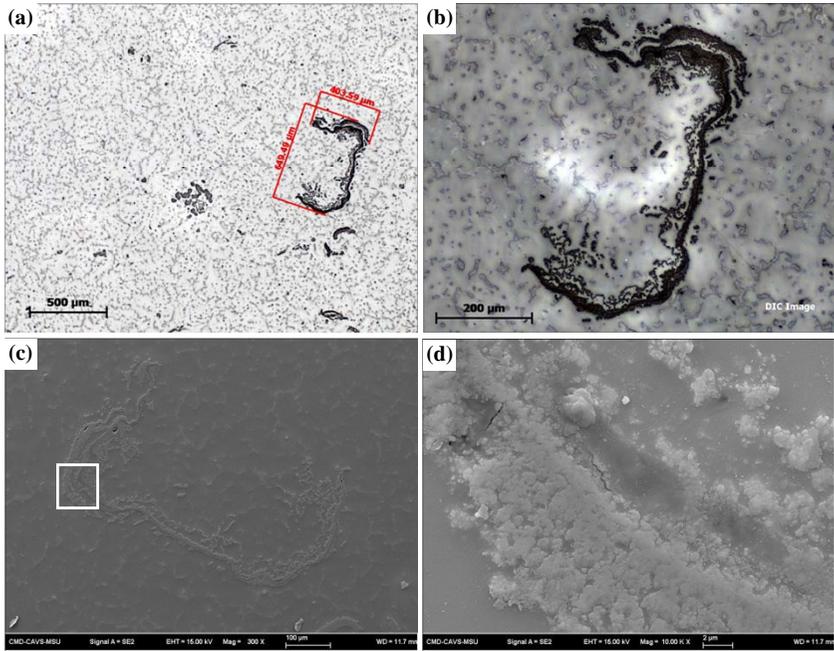
Figure 6. Oxide film in AZ91 sample C1. (a) Optical micrography; (b) Transmitted light differential interference contrast (DIC) image; (c) SEM image; (d) Higher magnification (10000X) of image (c).

Long pieces of oxide films, some longer than 1 mm, were observed in AZ91 samples through optical microscopy and in SEM images. Figure 6 shows a “dragon-shaped” oxide film found on a polished surface of the specimen. The distinct precipitation upon both sides of the film might suggest the former existence of a double oxide that was later torn open, with the higher precipitation occurring on the wetted side.

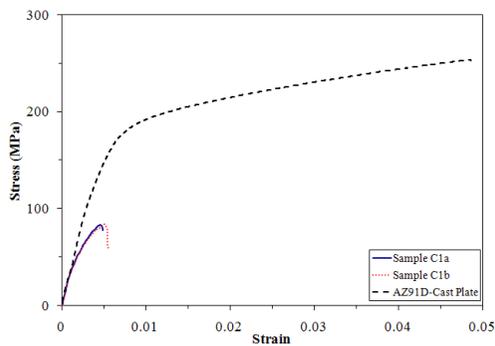
Figure 7. Tensile test results for strip specimens with a strain rate of 0.001/s; Specimen C1a and C1b were taken from different locations in AZ91 sample C1; The third specimen was taken from a AZ91D die cast plate.

Tensile tests performed on strip specimens at a strain rate of 0.001/s confirmed that oxides and porosity had a significant effect on the mechanical properties of AZ91. Figure 7 shows that the yield strength and ductility of two C1 samples of the gravity-poured ingots are considerably smaller than those of a AZ91D die cast plate of 3 mm thickness. The relatively good properties of the AZ91D sample is thought to be caused by the high velocity of the die casting process which possibly breaks the oxide films into very small parts [10].

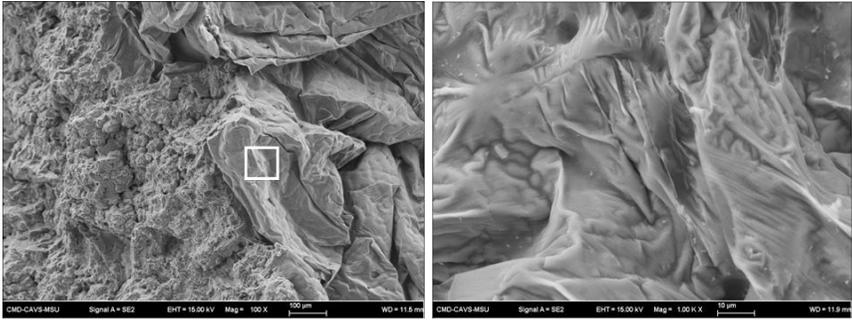
Figure 8. Scanning electron microscope images showing the interface region of the matrix and oxide film on fracture surfaces of a tensile test specimen taken from AZ91 sample C1.

The details of fracture surfaces of tensile test AZ91 samples are shown in Figures 8-10. A distinct interface between the dendritic matrix and an oxide region can be observed (Figure 8). Figure 9 shows two symmetrical oxide films on either side of a fracture surface. This agrees well with the observation by Griffiths and Lai [8] for pure Mg castings. A magnified view of the oxide region (Figure 10) reveals a pleated surface, similarly as observed in double oxide films in aluminum alloys.

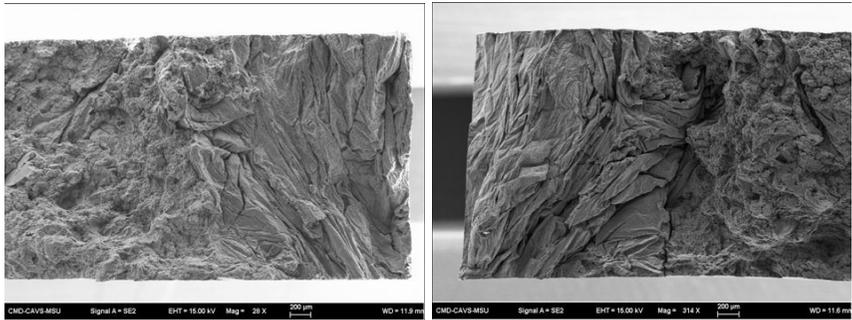
Figure 9. Scanning electron microscope images of oxide films on the two sides of the fracture surfaces of a tensile test specimen taken from AZ91 sample C1.

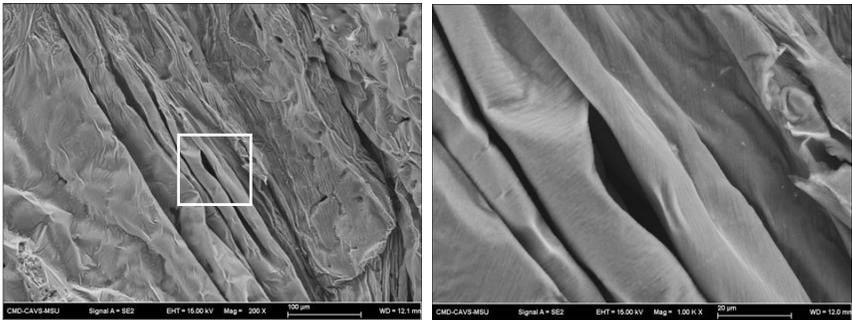
Figure 10. Higher magnification views of the oxide film found on the fracture surface shown in Figure 9.

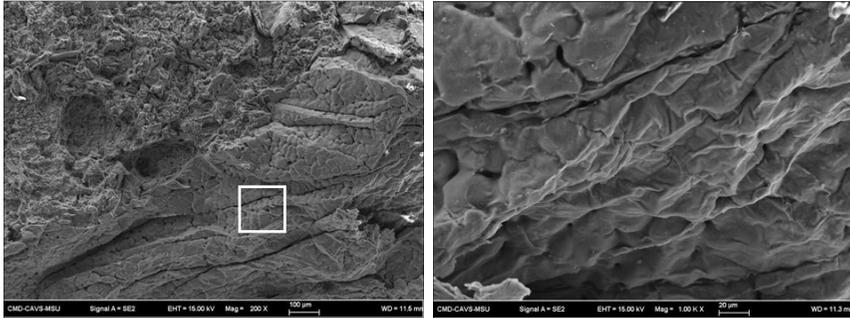
Figure 11. Scanning electron microscope images show the interface region of matrix and oxide film on fracture surfaces of a four point bending test specimen taken from AZ91.

SEM images of the fracture surfaces of a four-point bend specimen are presented in Figure 11. Again, an interface between the matrix and an oxide region can be detected. However, these surfaces look different than the fracture surfaces of the tensile test samples. They are darker and the oxide film is not pleated as the one in the tensile test fracture surfaces; instead, an apparently thinner film is folded over dendrites. Possibly, the different states of stress in comparison to the tensile test samples are in part responsible for these features.
